NO.: 24-129  
DATE: August 15, 2024  
TO: All Personnel  
FROM: Robert Logan, Deputy Fire Chief, Employee Services  
SUBJECT: Green Sheet – LAFD Truck/RV Fire – Firefighter LODD

# GREEN SHEET

### Firefighter Line of Duty Death

Incident Number LAC 24-203895

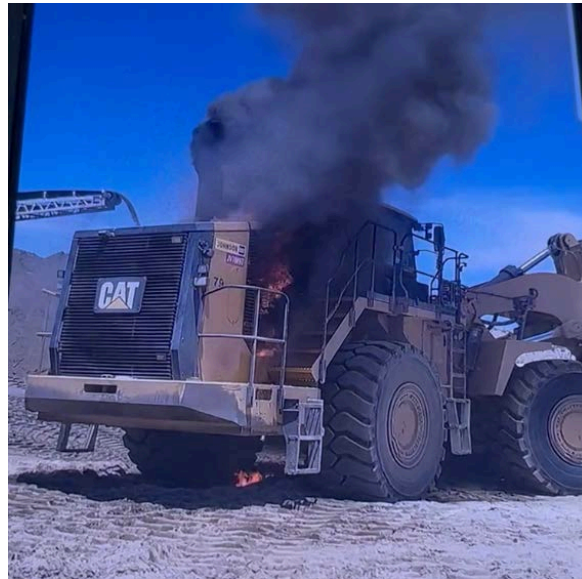
On Friday, June 14, 2024, the operator of wheel loader at a sand and gravel quarry was alerted to a fire at the rear of the vehicle. The operator discharged a 20 lb. dry chemical fire extinguisher into the engine compartment and exited the vehicle.

***Fire in engine compartment***

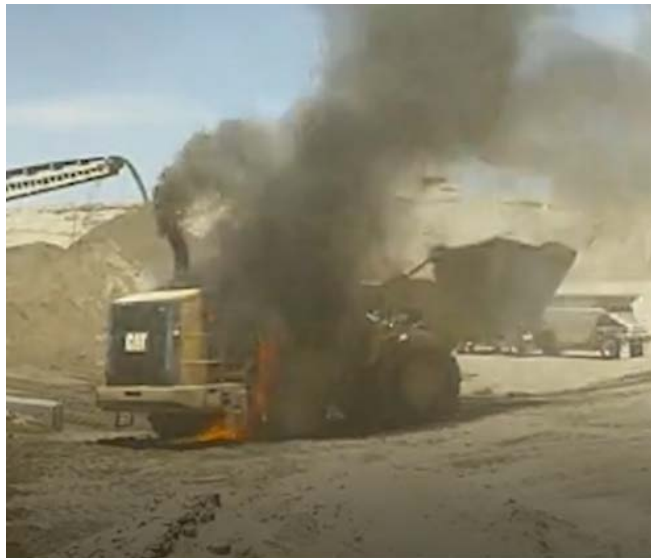
***Fire extending to the right-rear tire at 1441 hours.***

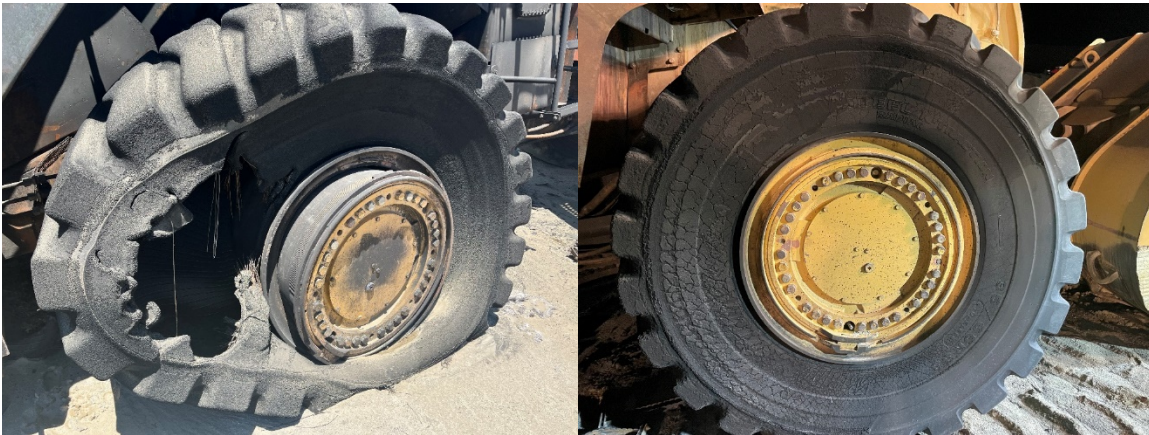
At 1402 hours, four minutes before the fire department arrived, the right-rear tire exploded. The blast broke the passenger side windshield of a quarry vehicle located approximately 120 feet away from the tire, but no facility personnel were injured. After the explosion, quarry personnel and equipment were relocated 200 feet away from the wheel loader.

*Right rear tire (left photo) and right-front tire (right photo)*

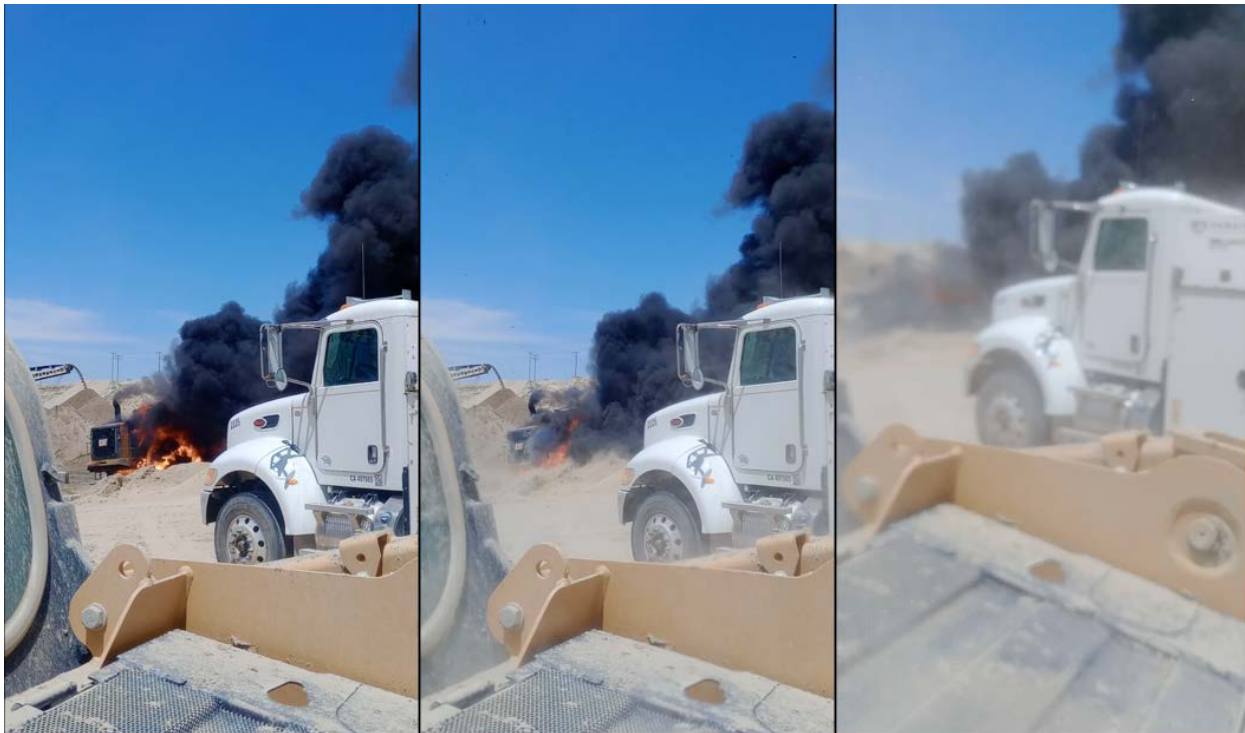
*Right-rear tire explosion prior to FD arrival. The windshield of the white truck was broken during the blast.*

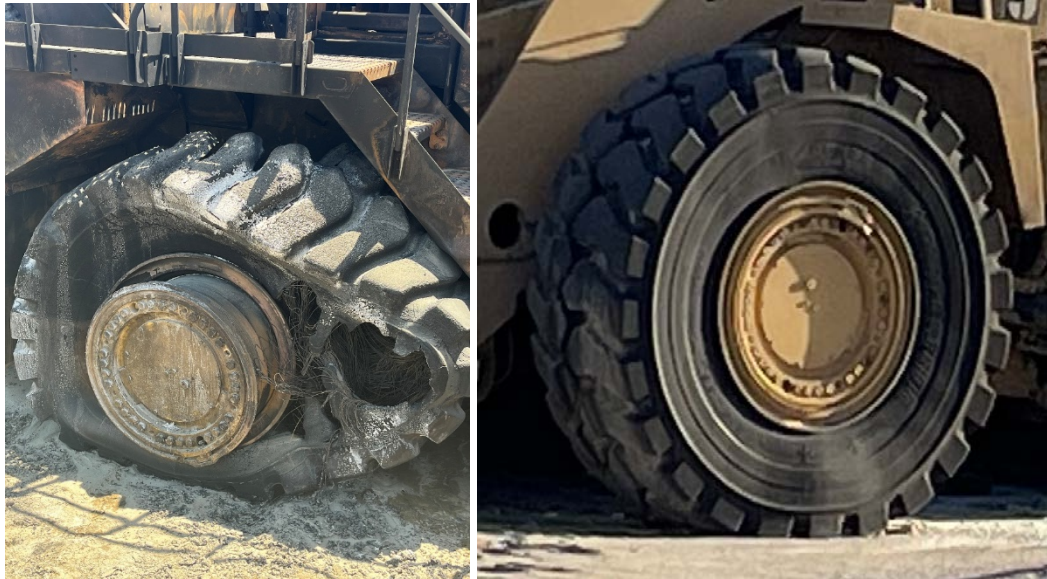
The force of the explosion expelled debris up to 350 feet from the left-rear tire. The left-rear tire explosion was more powerful than the right-rear tire explosion. Only the rubber and steel cord components of both tire's sidewalls were expelled during the explosion; the multi-piece rim assemblies remained intact.

*Left rear tire (left photo) and left-front tire (right photo)*

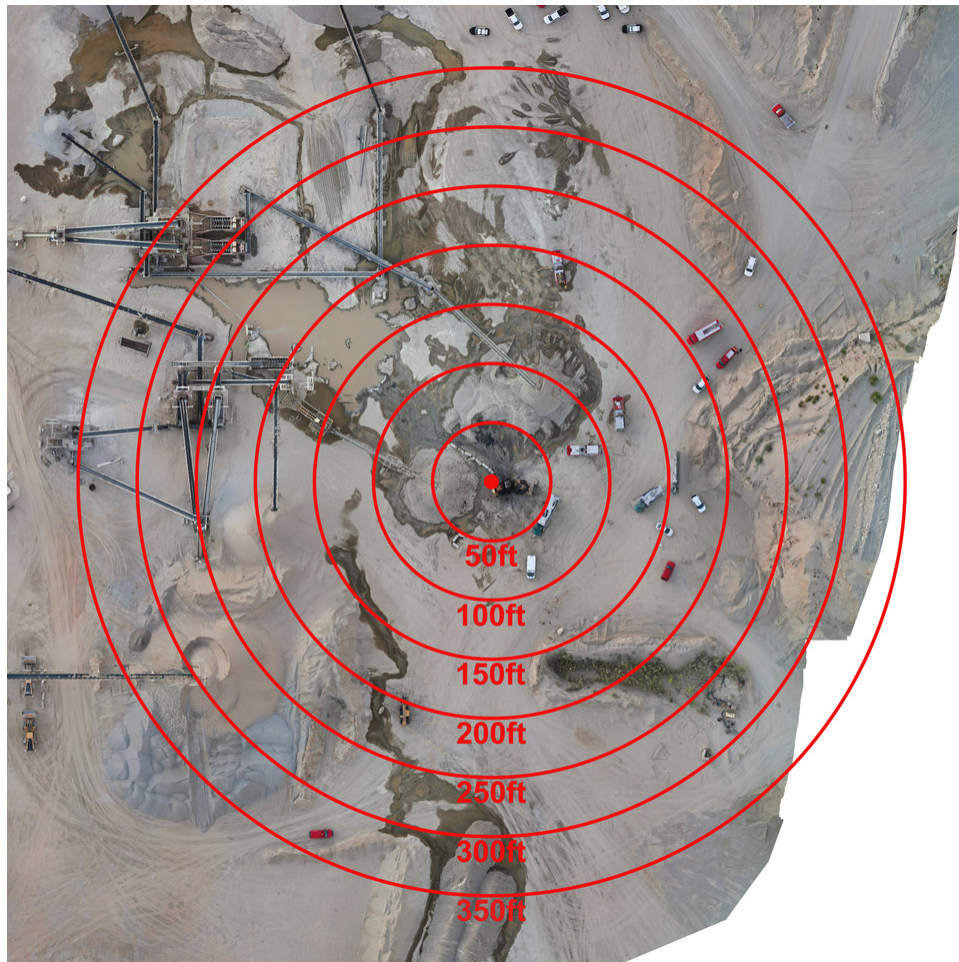
*Scaled overhead photo illustrating maximum distribution of debris.*

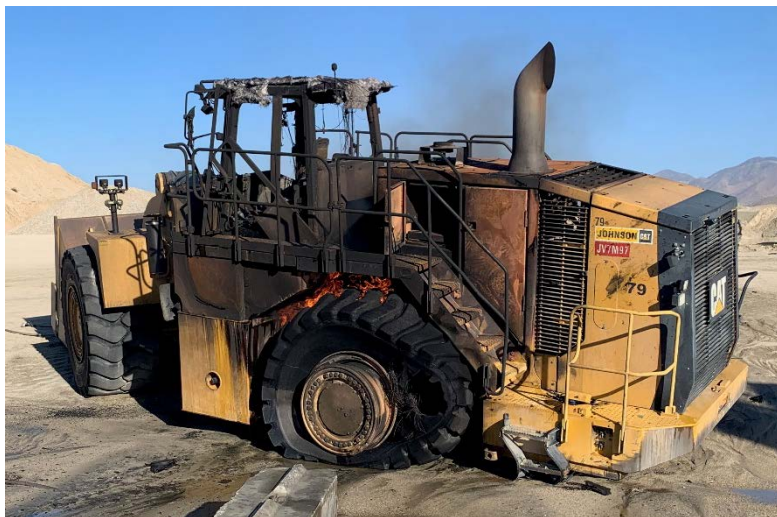
*Left rear of loader just prior to full extinguishment.*

After the bulk of the fire was knocked down, a 1 ¾-inch handline was utilized along with Firelce® powder to extinguish the remaining fire around the left-rear tire. Full extinguishment was achieved at approximately 1915 hours.

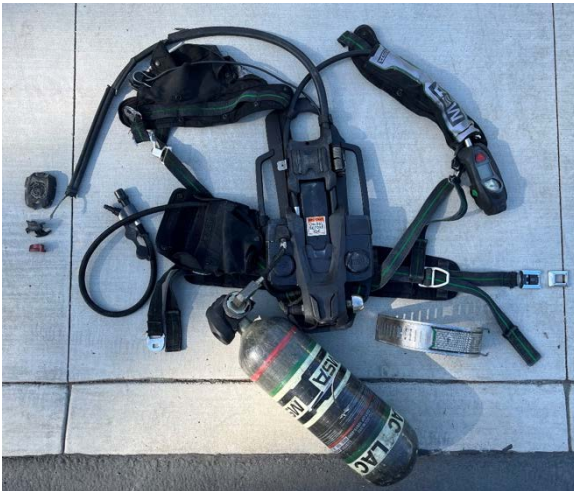
**FF1's SCBA**

- FF1's personal protective equipment, including radio and SCBA, were destroyed.
- One 1-inch reel line was destroyed.
- One 1-inch 10/40 gpm dual gallonage nozzle was destroyed.
- E93's engineer side windshield was broken.

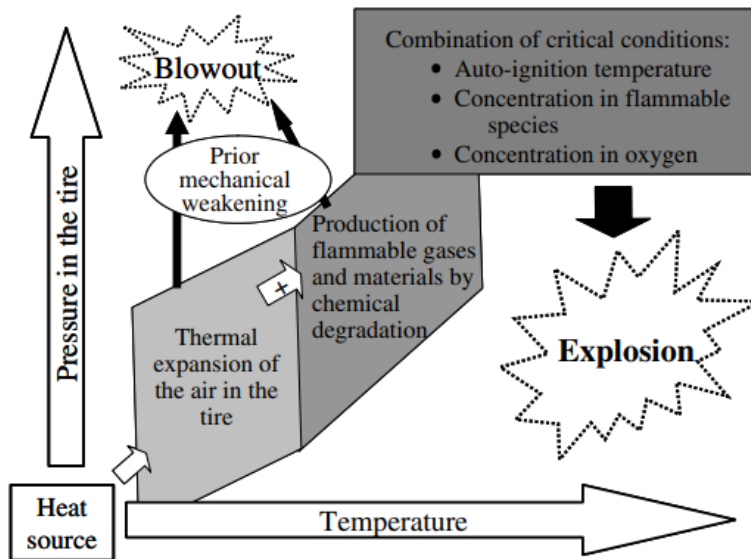
**Processes leading to tire blowout or explosion (Dolez et al., 2007)**

According to “Exploring the chemical aspects of truck tire blowouts and explosions” (Dolez et al., 2007), there is a distinction between a tire blowout and a tire explosion. A blowout is associated with the mechanical failure of the tire or rim assembly. Blowouts occurring while the vehicle is in motion typically generate pressures around 145 psi. A tire exposed to fire may blowout prior to explosion when the internal pressure increase exposes a mechanical defect within the tire or rim assembly. An explosion is a much more violent event involving flammable gases and is a result of the process discussed below.

There are three phases of the process that may lead to the explosion of tires exposed to heat. First, the air pressure inside the tire will increase as the temperature rises. The pressure of a tire inflated to 90 psi will rise to approximately 235 psi. Unless there is a mechanical defect within the tire or rim assembly, the pressure increase due to the expansion of the air inside the tire will not typically lead to failure (blowout).

Second, when the rubber of the tire reaches 365° Fahrenheit, it will undergo thermo-chemical degradation reactions and release gases within the tire. The gases released are added to the quantity of air already inside, increasing the pressure within the tire. There are two important things to note regarding these thermo-chemical degradation reactions:

- The reactions are exothermic, meaning they can continue inside the tire even if the external heat source is removed. Extinguishing a fire exposing or involving the tire may not stop the reactions and prevent a tire explosion.
- The gases produced inside the tire are flammable with a heat release comparable to that of natural gas.

Third, an explosion will occur when the oxygen concentration is at least 5.5 percent and the flammable gases reach their lower explosive limit and auto-ignition temperature. The explosion will generate shock waves and pressures over 1000 psi, projecting fragments outward at high velocity that travel great distances.
