BULLETIN

NO.: 24-197
DATE: December 26, 2024
TO: All Personnel
FROM: Willy Melendez, Deputy Fire Chief, Employee Services
SUBJECT: Green Sheet – LAFD Green Sheet – Helicopter Emergency

Apparatus Damaged from Helicopter Water Drop

**Franklin Incident
CA-LAC-24-434928**

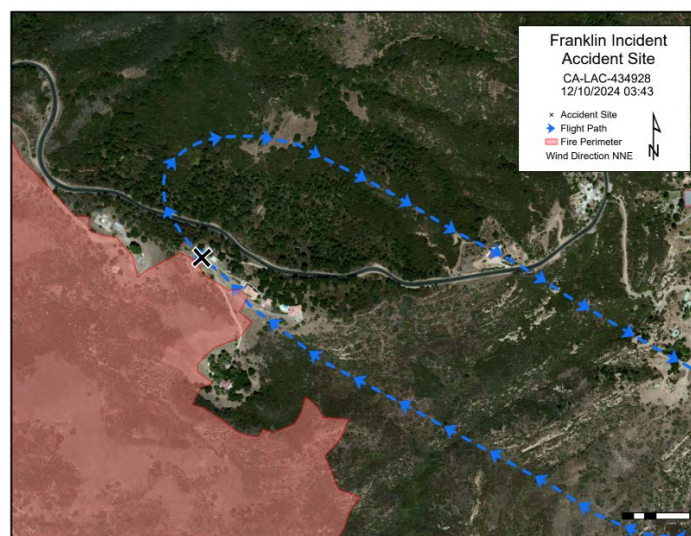
Actual Water Drop Footage

At 0343 hours, Strike Team Leader contacted HLCO and informed them that the last water drop struck one of his engines and that the engine was mechanically out of service with no injuries to personnel.

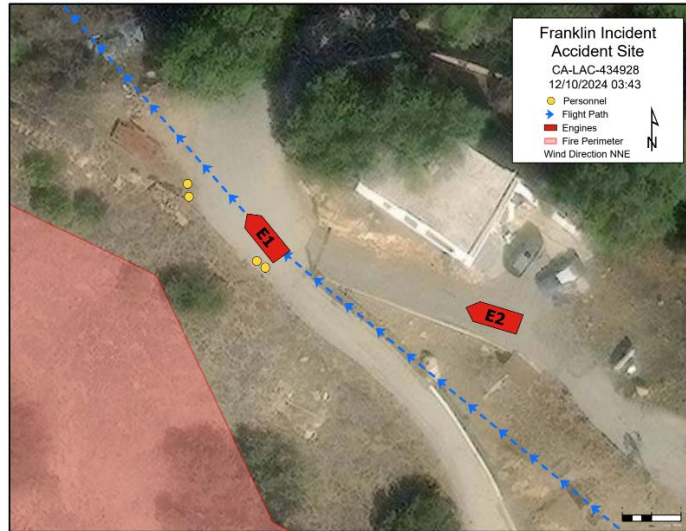
- The Type III engine sustained a broken windshield along with damage to the roof of the vehicle. The roof of the engine displayed buckling and deformation consistent with the impact of approximately half of the volume of water (approximately 700 gallons total) dispensed from the helicopter. All windows other than the front window remained intact without shattering. The light bar was fractured and displaced. The front grill was displaced and likely carried by the impact of the water to a location approximately 25 to 30 feet in front of the engine. There was other damage present to ancillary components. Despite the impact of a significant portion of a water drop from a Type I helicopter, the cab of the engine retained the characteristics of a survivable space.

- The Type III engine continued to run; however, all the engines audible mechanical function alarms activated and sounded until the engine was shut down.

- Understand the dangers of aerial water and retardant drops, especially at night.
- Transmit a read back of critically received radio transmissions such as priorities, locations of resources, and hazards.
- Personnel assigned to an incident where aircraft are being utilized must understand where ground resources are assigned and working. This is especially true when aircraft are working in proximity to ground crews.
- Aircraft must coordinate with ground resources to clear the line and be prepared for the potential of a “go-around” if not verified.
- Helicopters shall not drop until the line is confirmed clear.
- Always conduct a risk/benefit analysis when engaging aircraft in proximity of ground resources and provide training to correct any normalization of deviance from safe line clearance principles.
