NO: 25-138  
DATE: August 6, 2025  
TO: All Personnel  
FROM: Daniel Eddy, Assistant Fire Chief, Operations  
SUBJECT: Green Sheet – CalFire Border 79 Incident

# GREEN SHEET

### "Border 79"

December 10, 2024  
Incident Number 24CASDU026957  
Barrett Truck Trail  
Dulzura, California

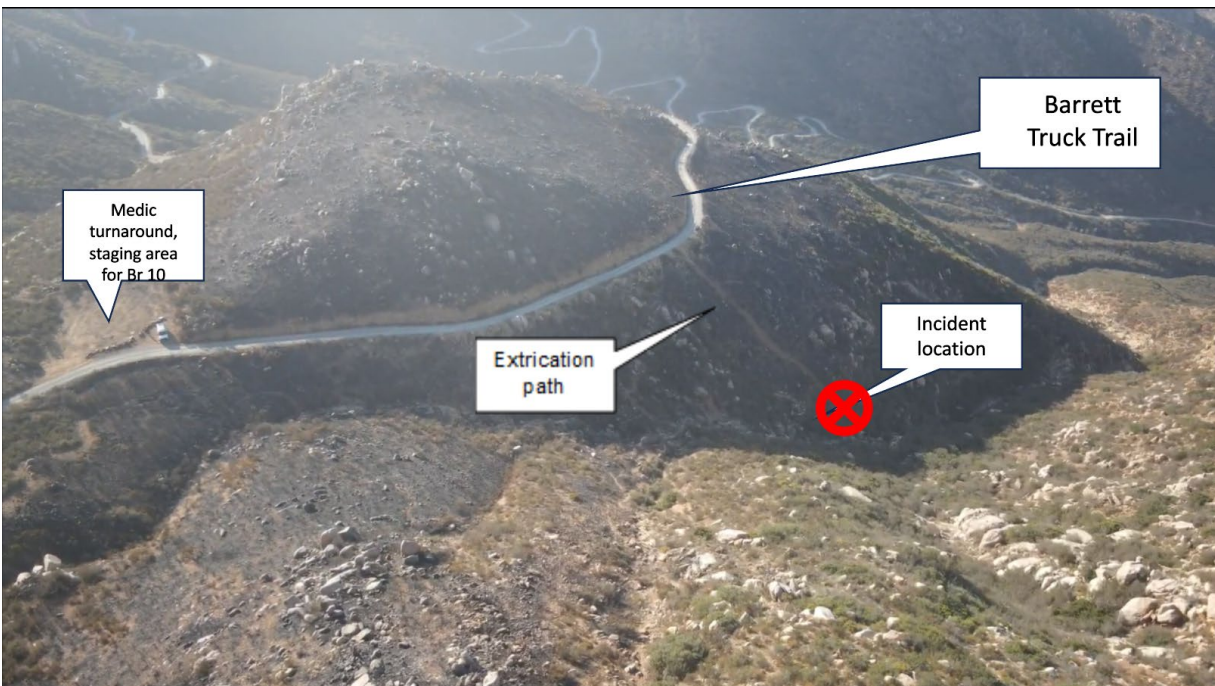
Picture 2 – Aerial Photo of Incident Site

- The accident site location is mid-slope above a drainage that runs Northwest between two mountains, approximately 250 feet below a truck trail. The average slope from the ridgeline to the drainage is 60 degrees.
- Elevation: 1600 feet.
- Aspect: Northwest.

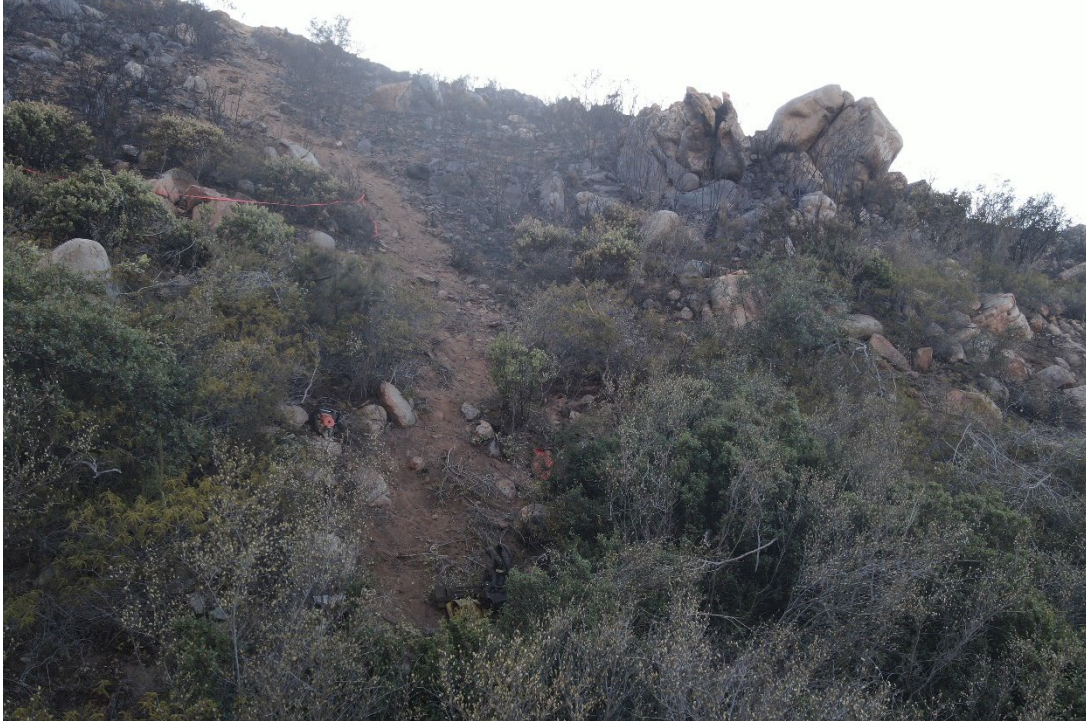
Picture 3 – Looking Uphill from Incident Site

- The escape routes were readily accessible, but the time factor prevented the team from exiting the boulder’s path of travel.
  - As the terrain was scouted, no boulders were explicitly identified as particularly precarious or needing to be avoided. The brush was later described as being “nuked out” and burned down to the soil. Personnel at the scene suggested that heavy brush on the ground may have been supporting the boulder.

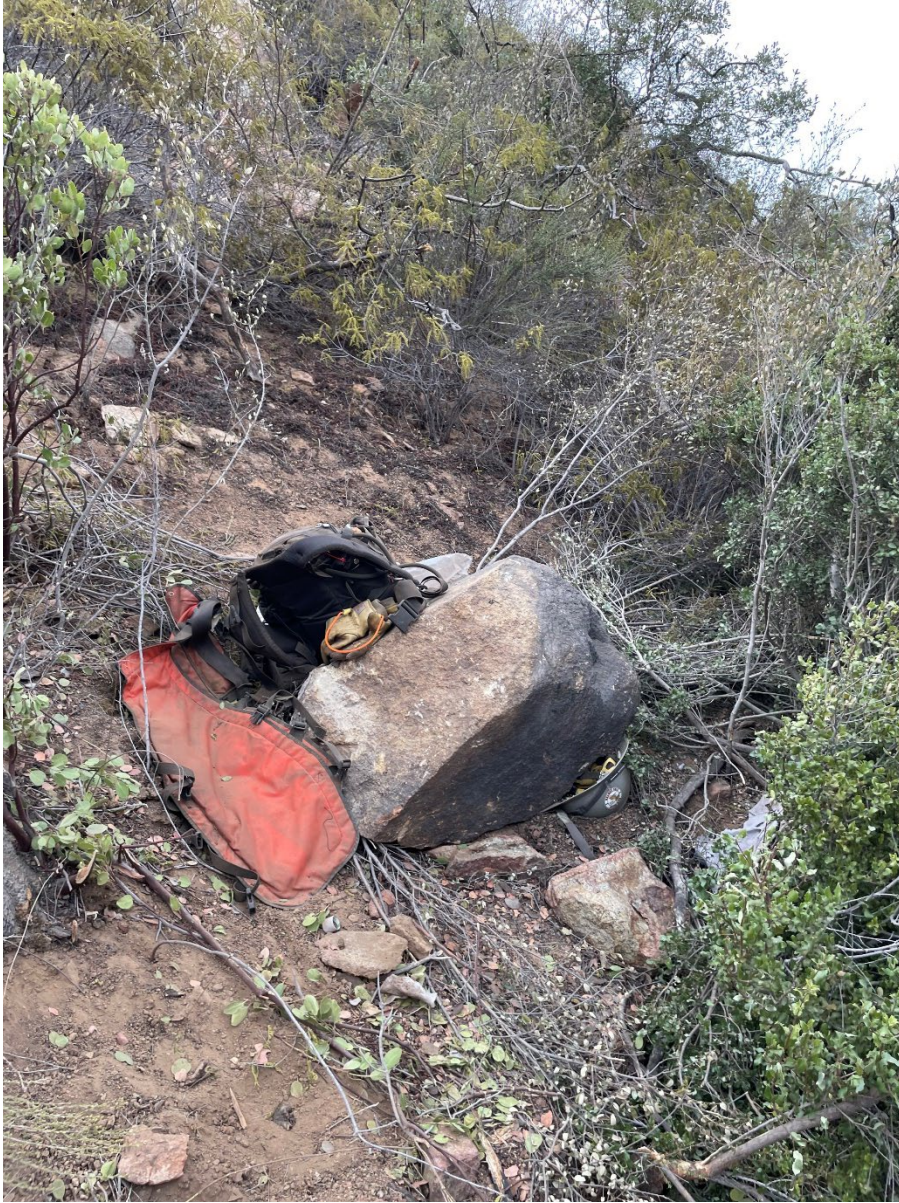
Picture 4 – Boulder and Victim PPE

**Damages:** Patient #1 helmet was severely damaged by the boulder strike.

- The individual with the head injury had an ANSI Z89.1 compliant helmet, which is designed to manage the force coming on the crown of the helmet, not laterally as in a boulder strike.

- Ultimately, there is no way to know how and why the boulder decided to begin rolling when it did. Personnel at the scene stated that a Type I helicopter had flown low over the site approximately 30 minutes before the boulder fell. While the fire apparatus used the road, there were no stops or idling. The material around the incident had been described as "nuked out," meaning it burned to the dirt. It was suggested that the brush beneath the boulder supported it, and after it burned away, the boulder simply snapped the brush under its own weight.

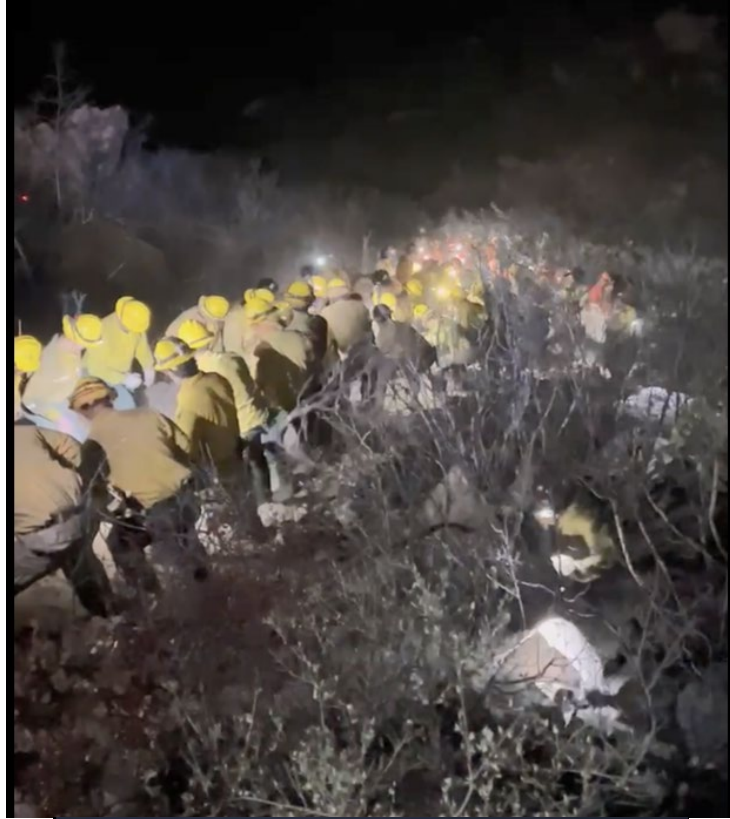
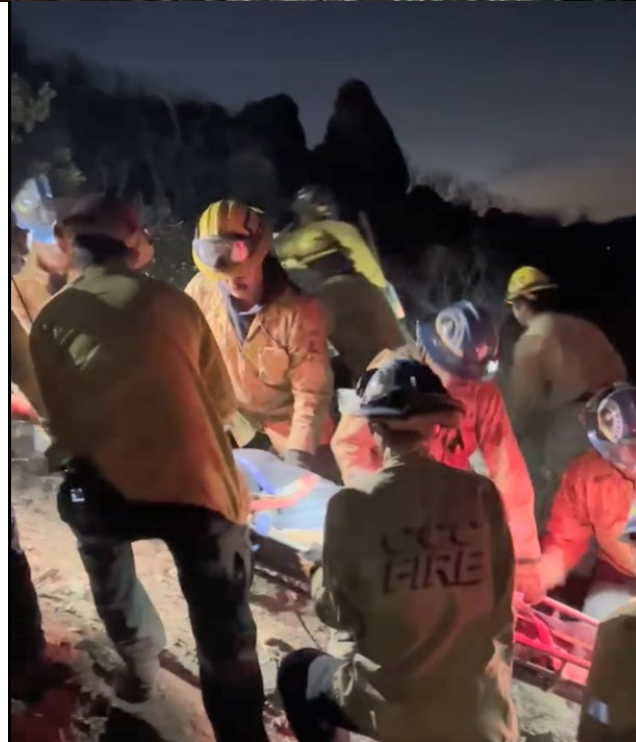
Pictures 5 & 6 – Caterpillar Rescue Evolution

While BR10 and SDC4 rendered patient care, DIVS A developed a rescue plan. With sufficient manpower at the scene and a clear line of travel courtesy of SDC1's efforts, DIVS began organizing a "caterpillar" rescue evolution. This involved several dozen firefighters lining up shoulder to shoulder and passing the litter up the slope.
