**NO:** 25-143  
**DATE:** August 21, 2025  
**TO:** All Personnel  
**FROM:** Willy Melendez, Deputy Fire Chief, Employee Support Services  
**SUBJECT:** Green Sheet – CAL FIRE – Canyon Incident, Vehicle Rollover

## Canyon Incident

### Vehicle Rollover with Injuries

CA-VNC-068268

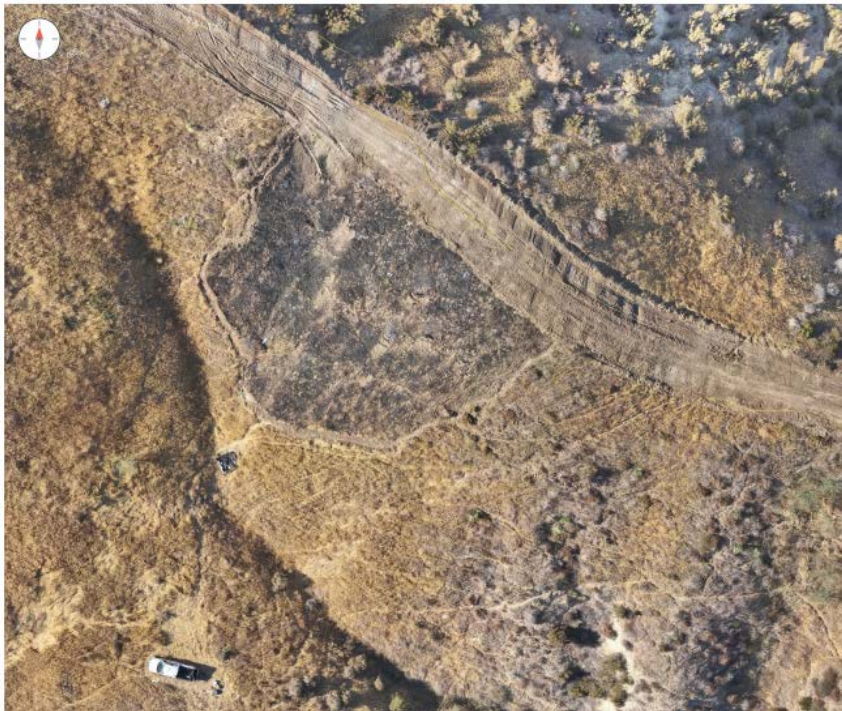
While attempting to position the vehicle, P1 left the dozer line and rolled approximately five times down into a canyon. The vehicle ultimately came to rest on its four wheels on a mid-slope knob. D1 was ejected from P1 as it rolled down the canyon.

*Figure 1: Aerial view of the accident site*

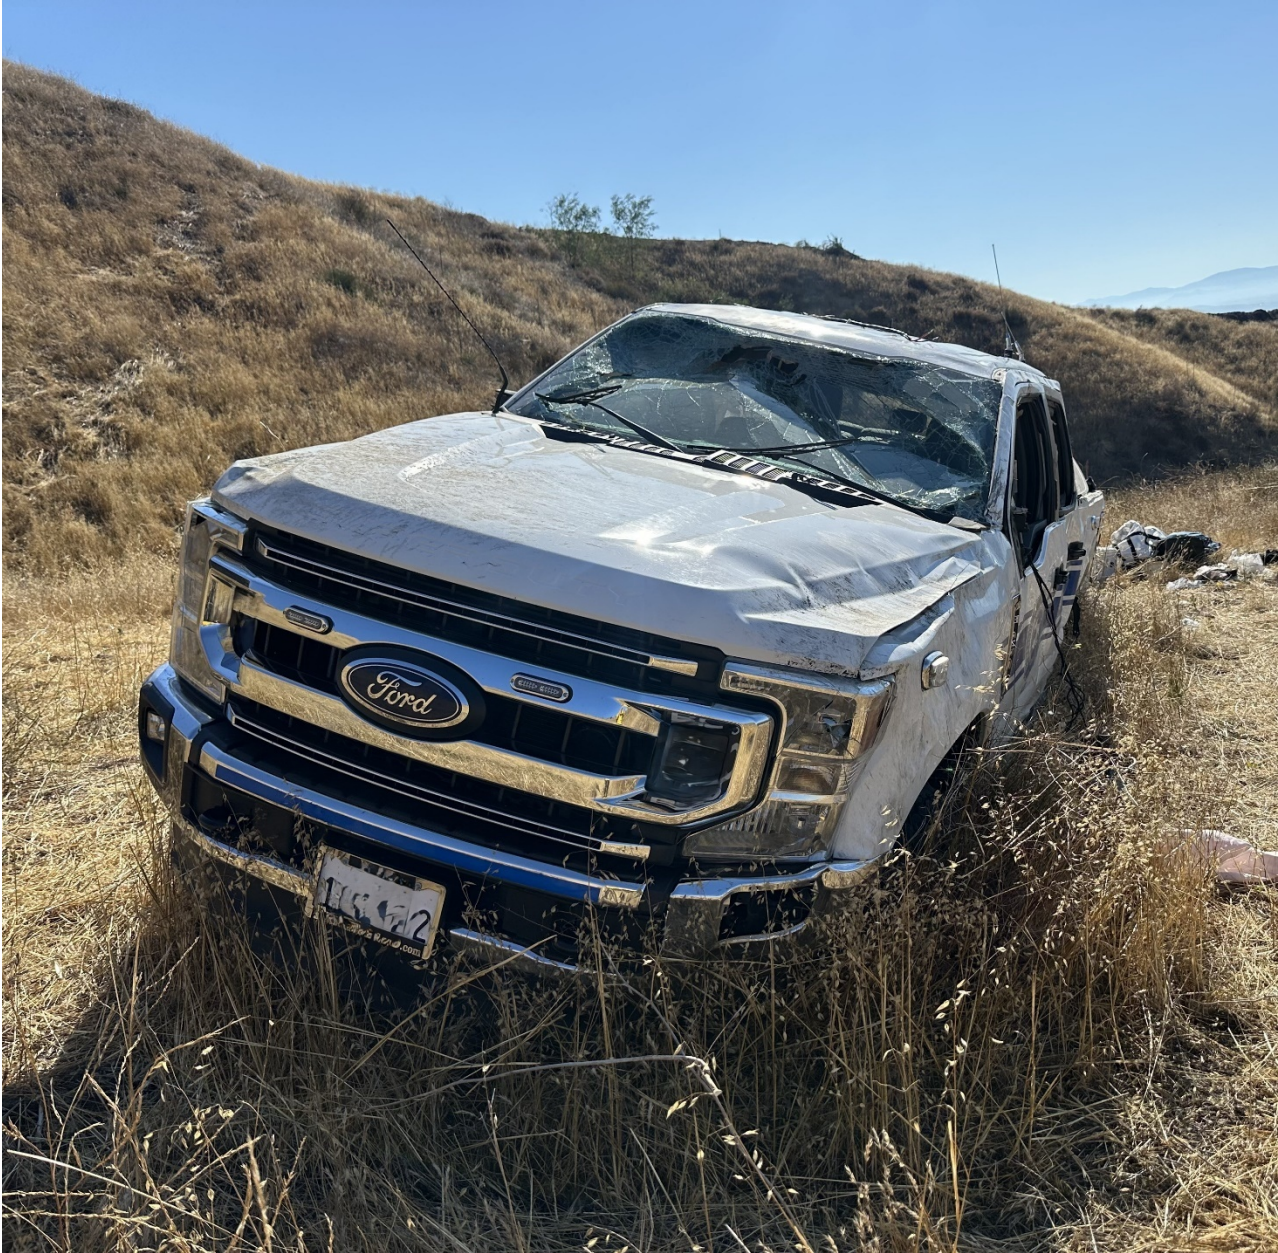
- D1 suffered major injuries.
- P1 sustained major damage.

*Figure 2: Pickup (P1)*

- Ensure the use of seatbelts during all vehicle operations. [ARTICLE 3. Safety Belts and Inflatable Restraint Systems \[27302 - 27319\]](#)
- Review IWI and 8-Line procedures (Page 120) with personnel. [NWCG Incident Response Pocket Guide, PMS 461](#)
- Revisit safe driving procedures. [Interagency Standards in Fire and Fire Aviation Operations \(Red Book\) Safety & Risk Management, Chapter 7](#)

- **Seatbelts** - Emphasize the importance of wearing seatbelts.
- **Scout Ahead** - Ensure resources scout ahead to identify hazards and confirm safe ingress and egress prior to committing apparatus or personnel.
- **Risk Management Process** - Apply risk management principles throughout incident operations to identify hazards, assess risk, and implement controls.
- **Vehicle Limitations** - Consider the limitations of apparatus operating on unimproved surfaces when selecting routes or positioning resources.
- **General Environmental Conditions** - Evaluate environmental conditions that may affect the safety and drivability of roadways before committing the apparatus.

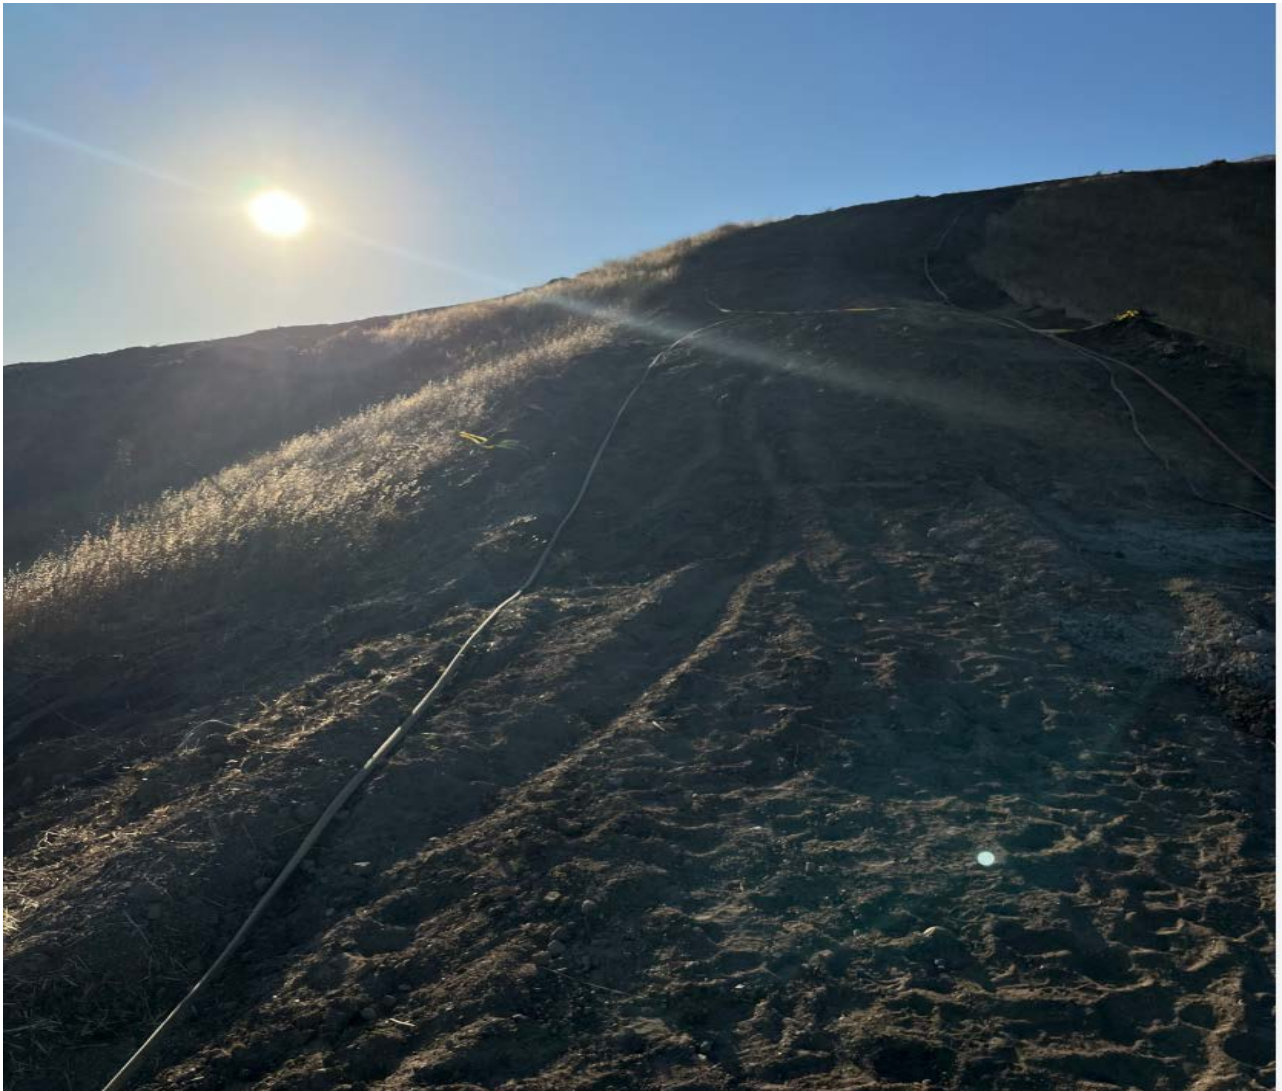
**Surface Conditions:** Dozers extended off of a two-track road, up a prominent ridge previously used as a containment line. The slope of the dozer line at the accident site was recorded at 22 percent. A majority of the surface was dry; however, moisture was present in areas from previous firefighting activities. The area around the tire tracks was soft and had been disturbed due to earlier dozer operations.

*Figure 3: Driver's point of view at 1830 hours*

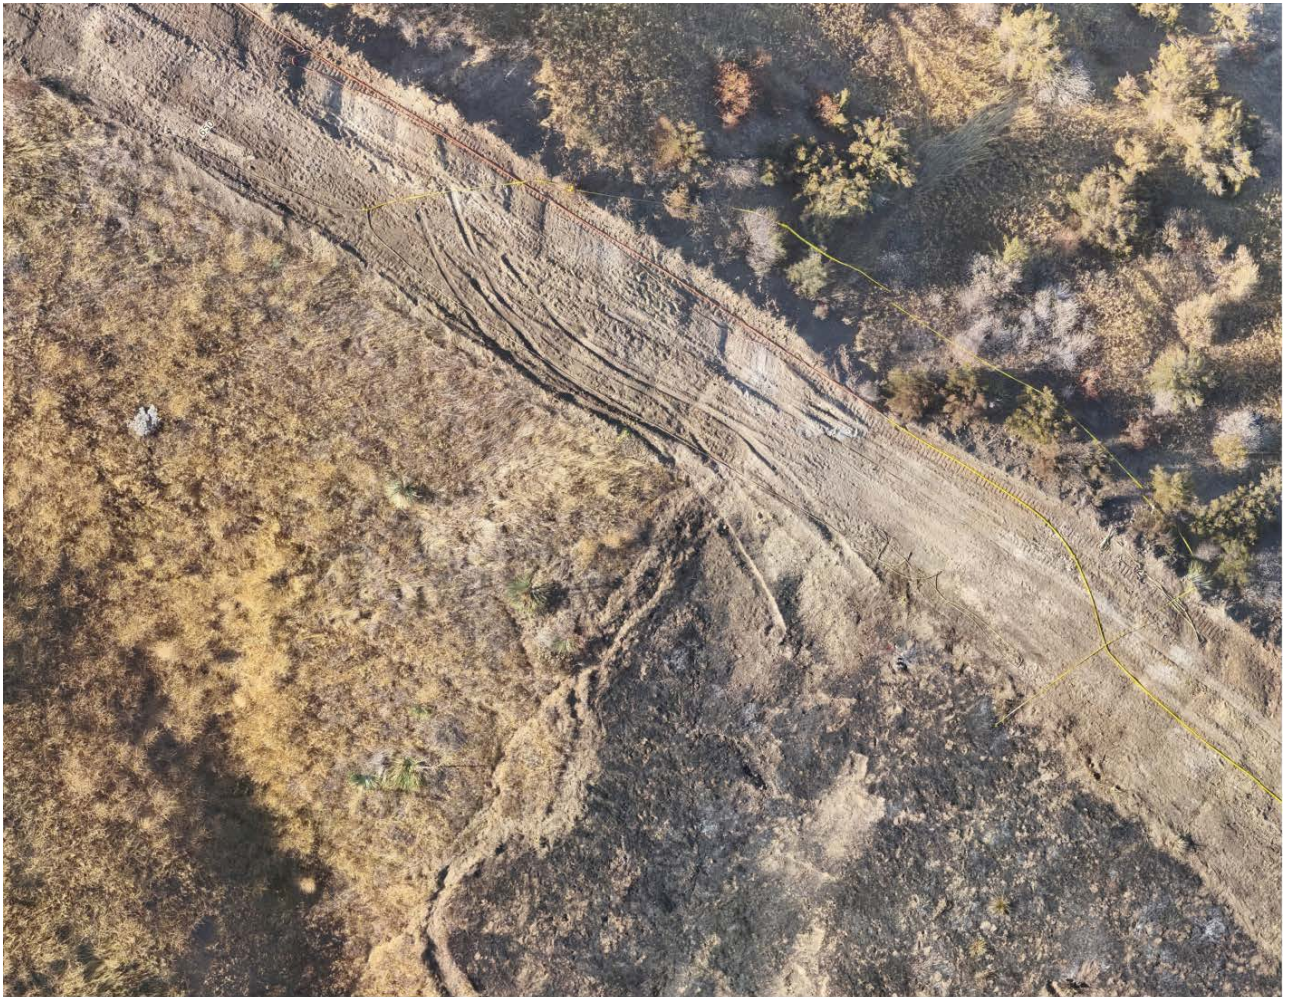
On August 8, 2025, at approximately 1830 hours, a utility pickup truck driven by a single individual, lost traction while ascending a dozer line during wildfire suppression operations. The vehicle subsequently left the dozer line and rolled down a steep canyon slope. An Incident Within an Incident (IWI) was declared immediately, and nearby emergency personnel rendered aid. The driver suffered major injuries and was airlifted from the scene to a local trauma center.

*Figure 4: Pickup (P1) path of travel*
