BULLETIN

NO: 26-017
DATE: February 11, 2026
TO: All Personnel
FROM: Daniel Eddy, Assistant Fire Chief, Operations
SUBJECT: Green Sheet – SDFD's South Mission Beach Jetty Incident

GREEN SHEET

"South Mission Beach Jetty Incident"

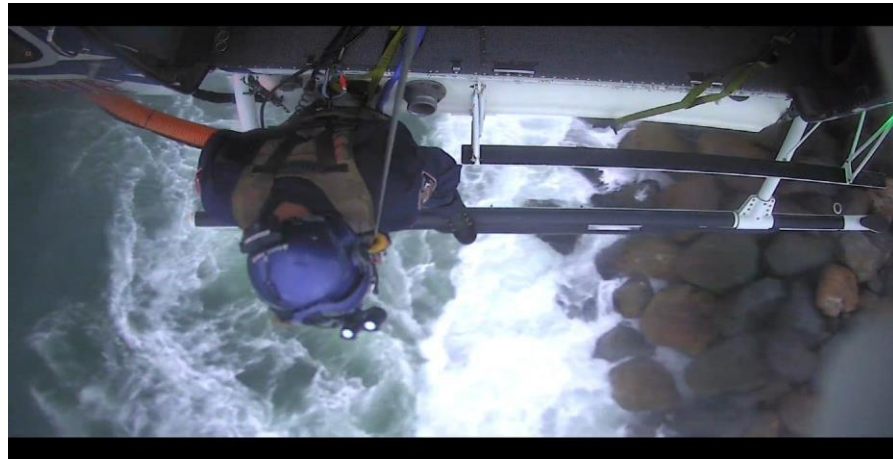
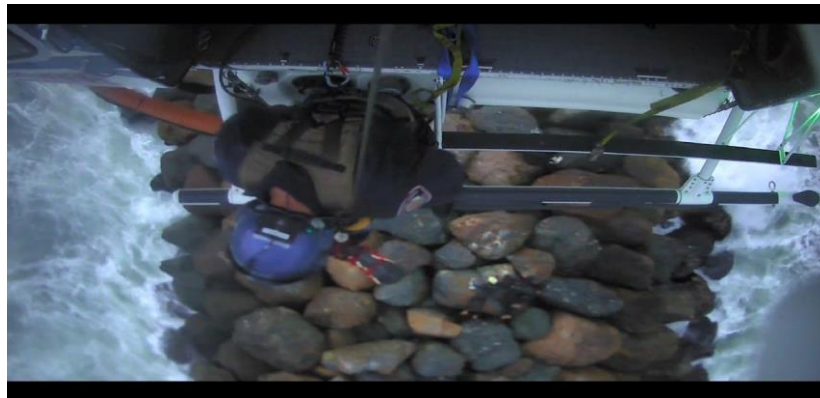
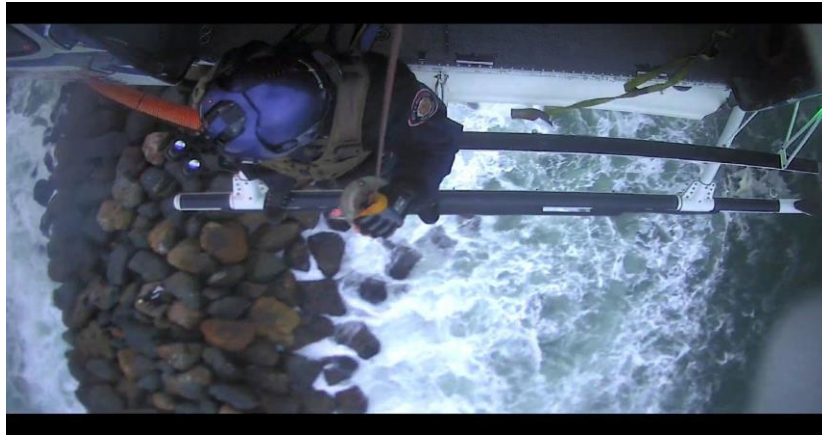
Heavy surf conditions at victim's location

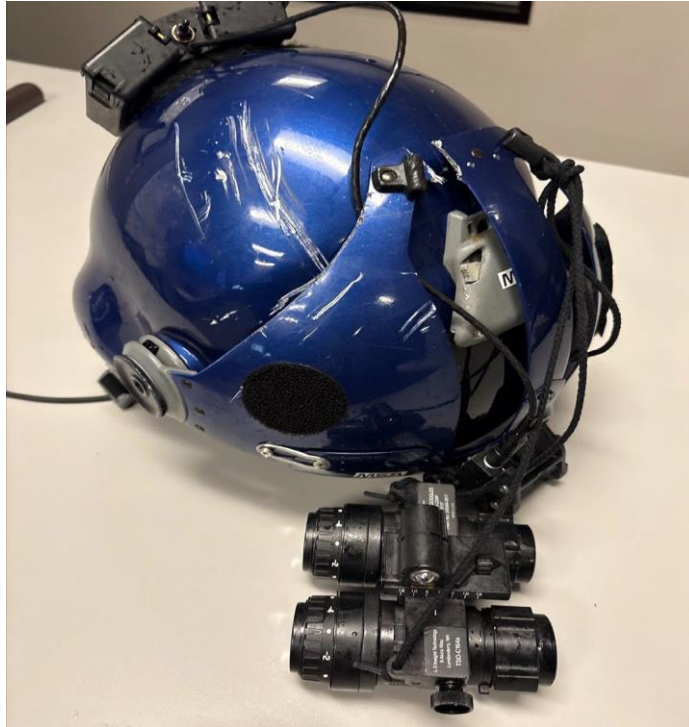
- Crew and operators were efficient in using hand signals to communicate the number of patients, their status, and whether a helicopter was needed. Operators shared information with IC in a timely fashion.
- It was recognized that a radio was needed at the rescue site, and a rescuer with a portable radio was deployed.
- Initial rescuers would benefit from having a radio on their initial contact.
- The HRM hands-free helmet comms continued to function after the impact with the jetty rocks, resulting in severe damage.

Picture 1- HRM helmet after being struck against rocks by waves.

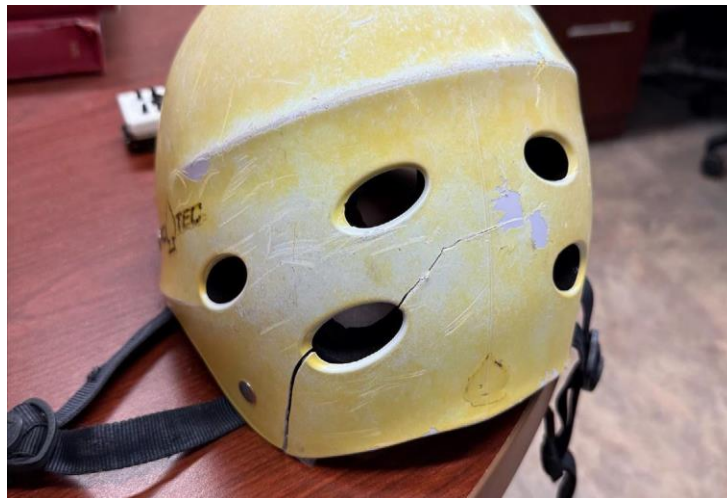
Picture 2- Lifeguard helmet after being struck against rocks by waves.

- For rapidly expanding / complex incidents, consider utilizing a Battalion Chief and command vehicle for unified command / ICP.
- Consider formal PPE guidelines for lifeguards.
- Consider SOGs for Jetty Rescues

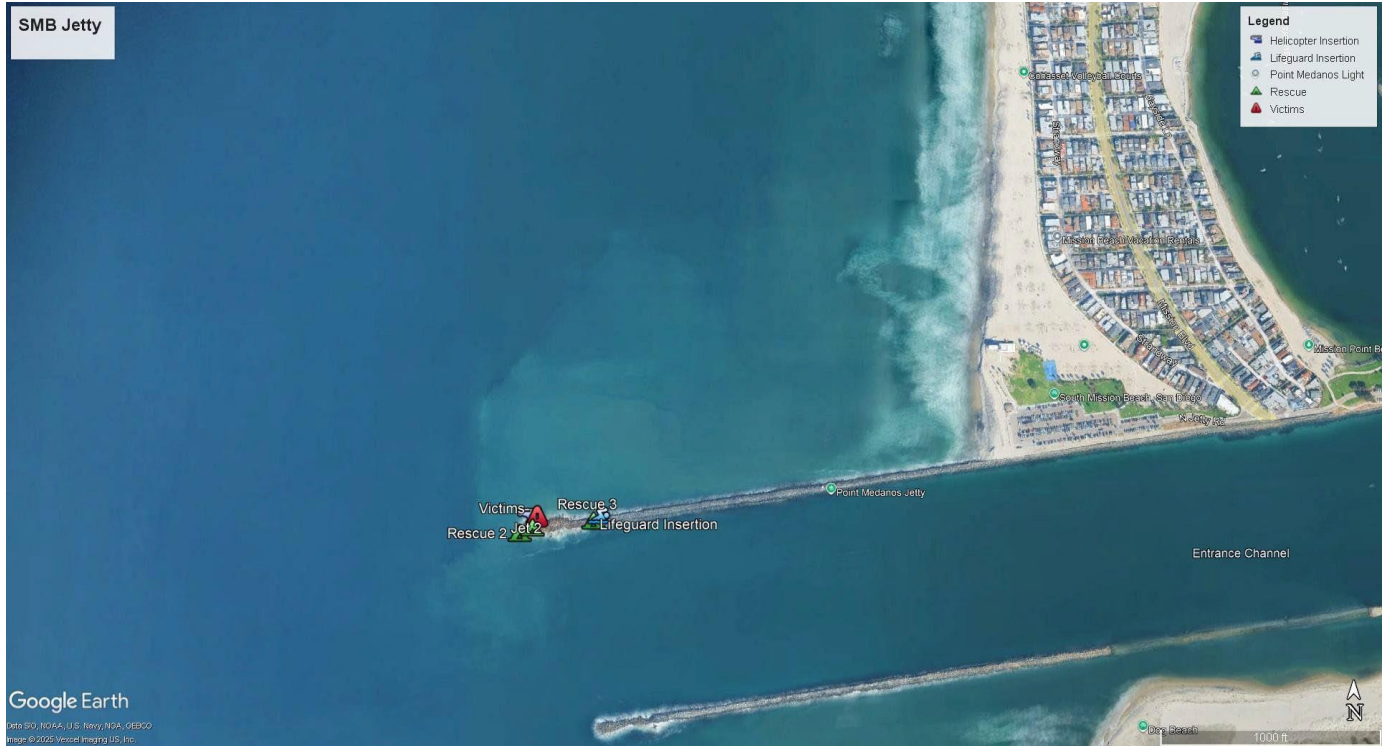
Picture 3 – Overview of Jetty, Victims, Helicopter, and LG Personnel

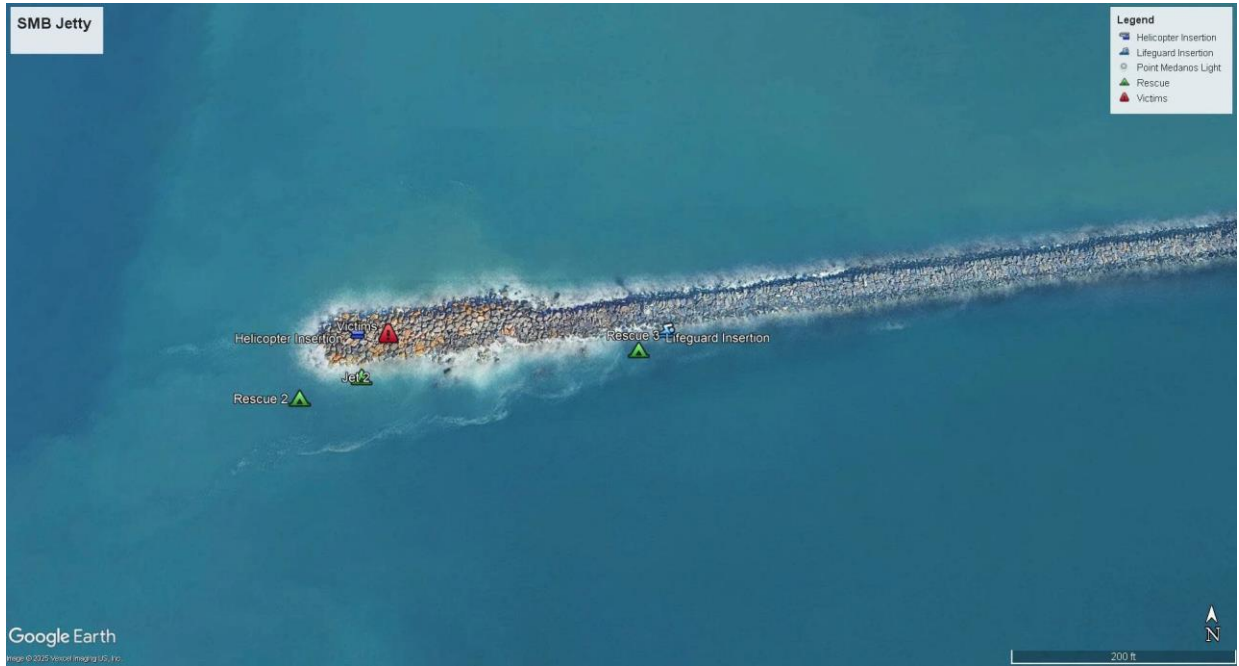
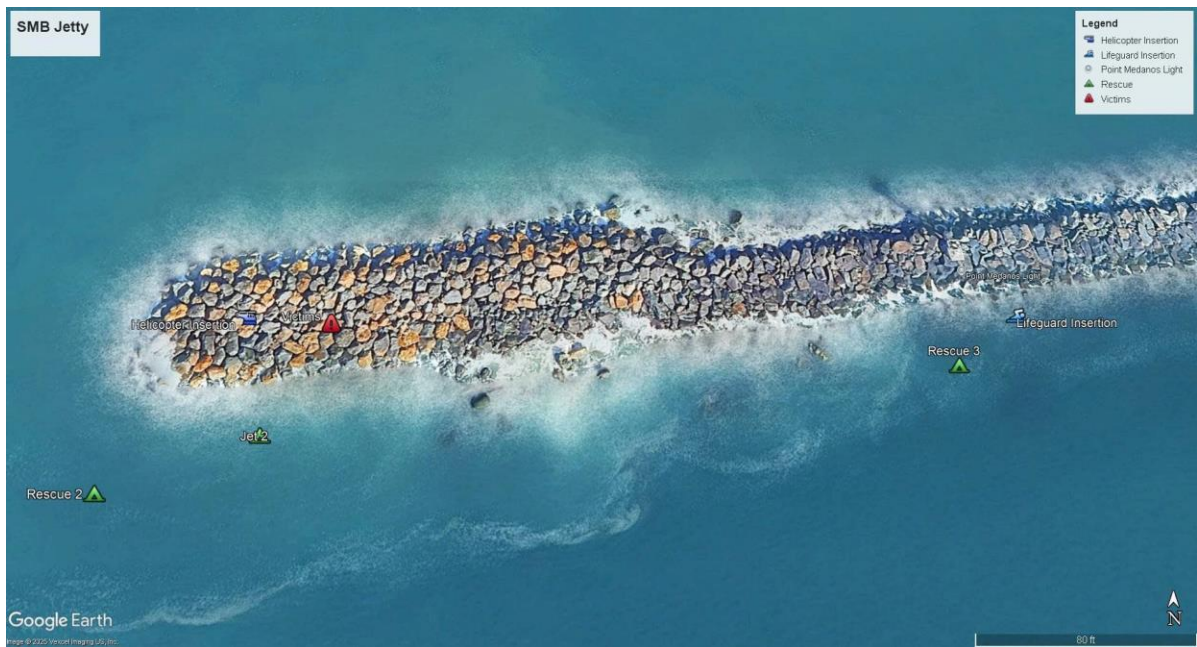
Pictures 4 & 5 – Static locations of LG Rescue Vessels, Insertion Points, and Victims

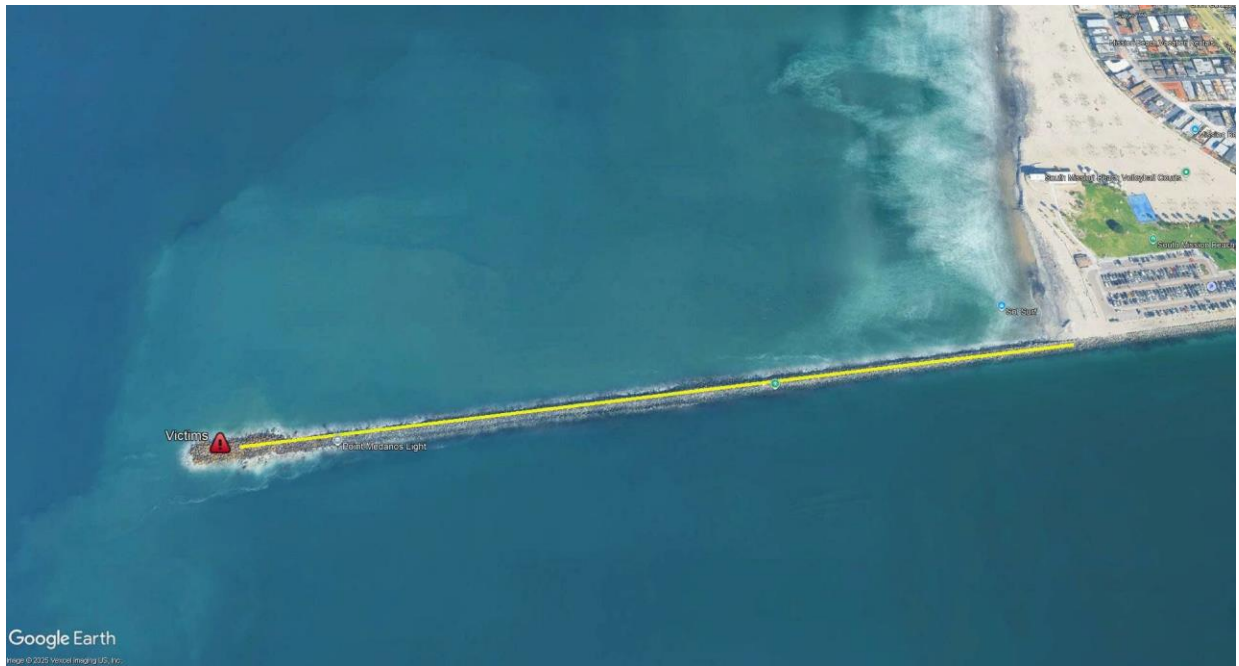
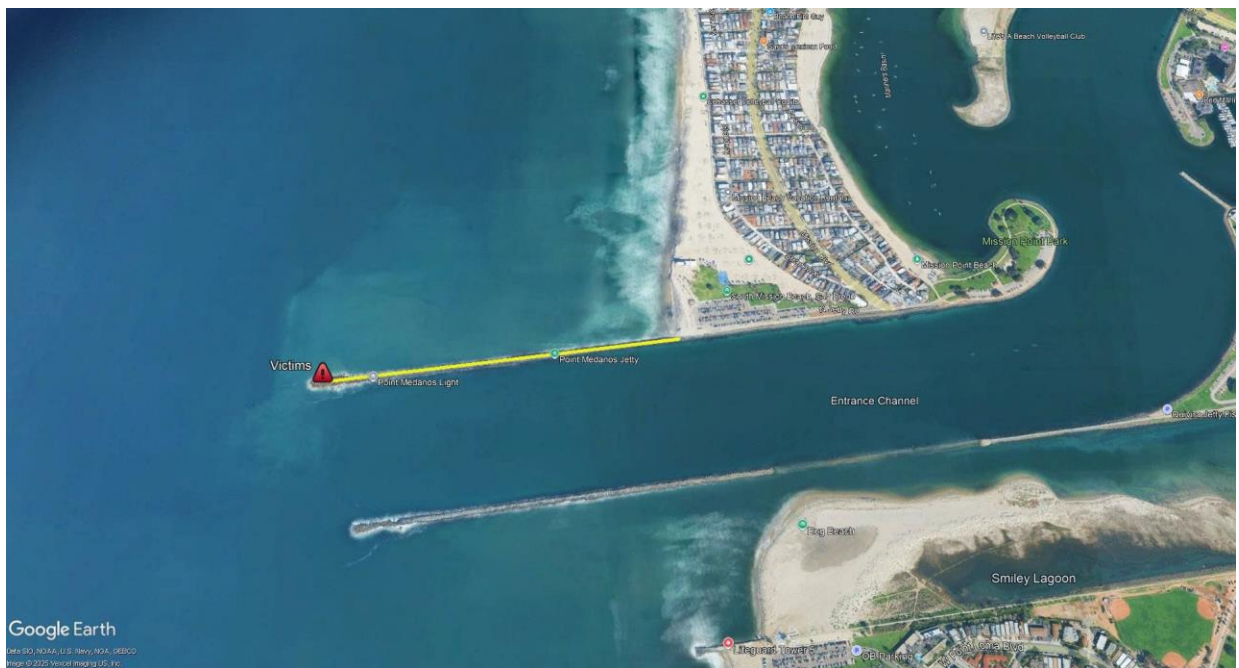
Pictures 6 & 7 - Overview of Jetty Walk Extraction (yellow)

.40 mile Jetty Walk
