NO.: 25-103  
DATE: June 17, 2025  
TO: All Personnel  
FROM: Daniel Eddy, Assistant Fire Chief, Emergency Operations  
SUBJECT: Green Sheet – Sacramento FD – Electric Vehicle Fire

# **GREEN SHEET**

**Electric Vehicle MVA and ensuing fire—causing  
respiratory injuries to responding firefighters.**

**April 11, 2025**

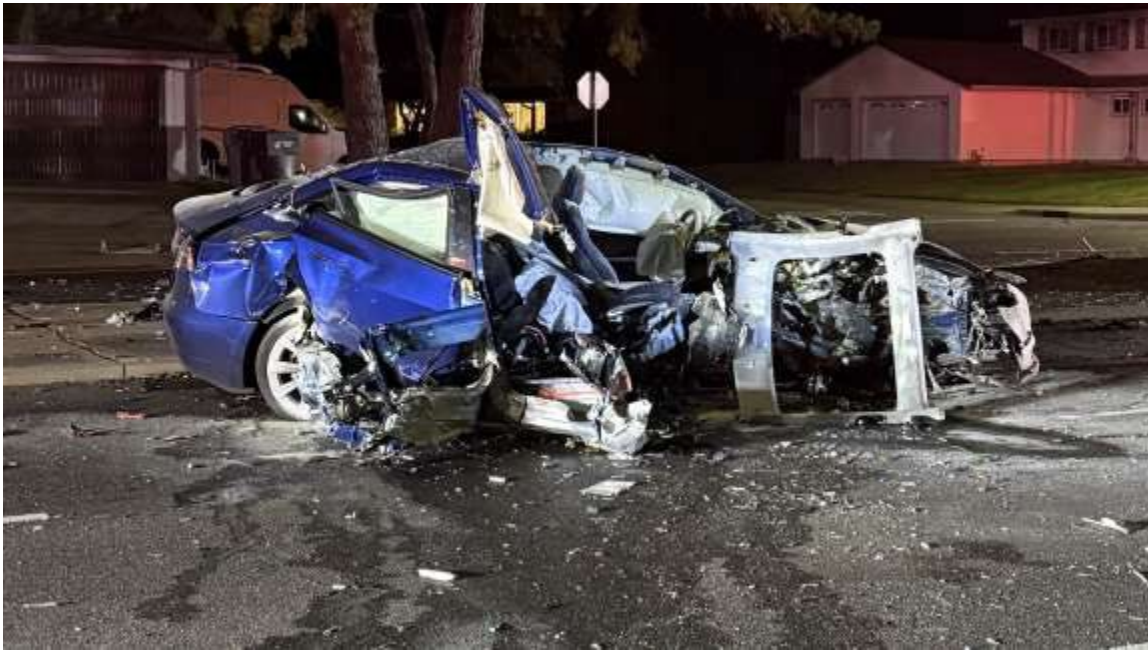
- The vehicle's battery pack was compromised and had over 400 scattered battery cells across the roadway. A typical Tesla Model S LIB pack contains ~7,500 cells.

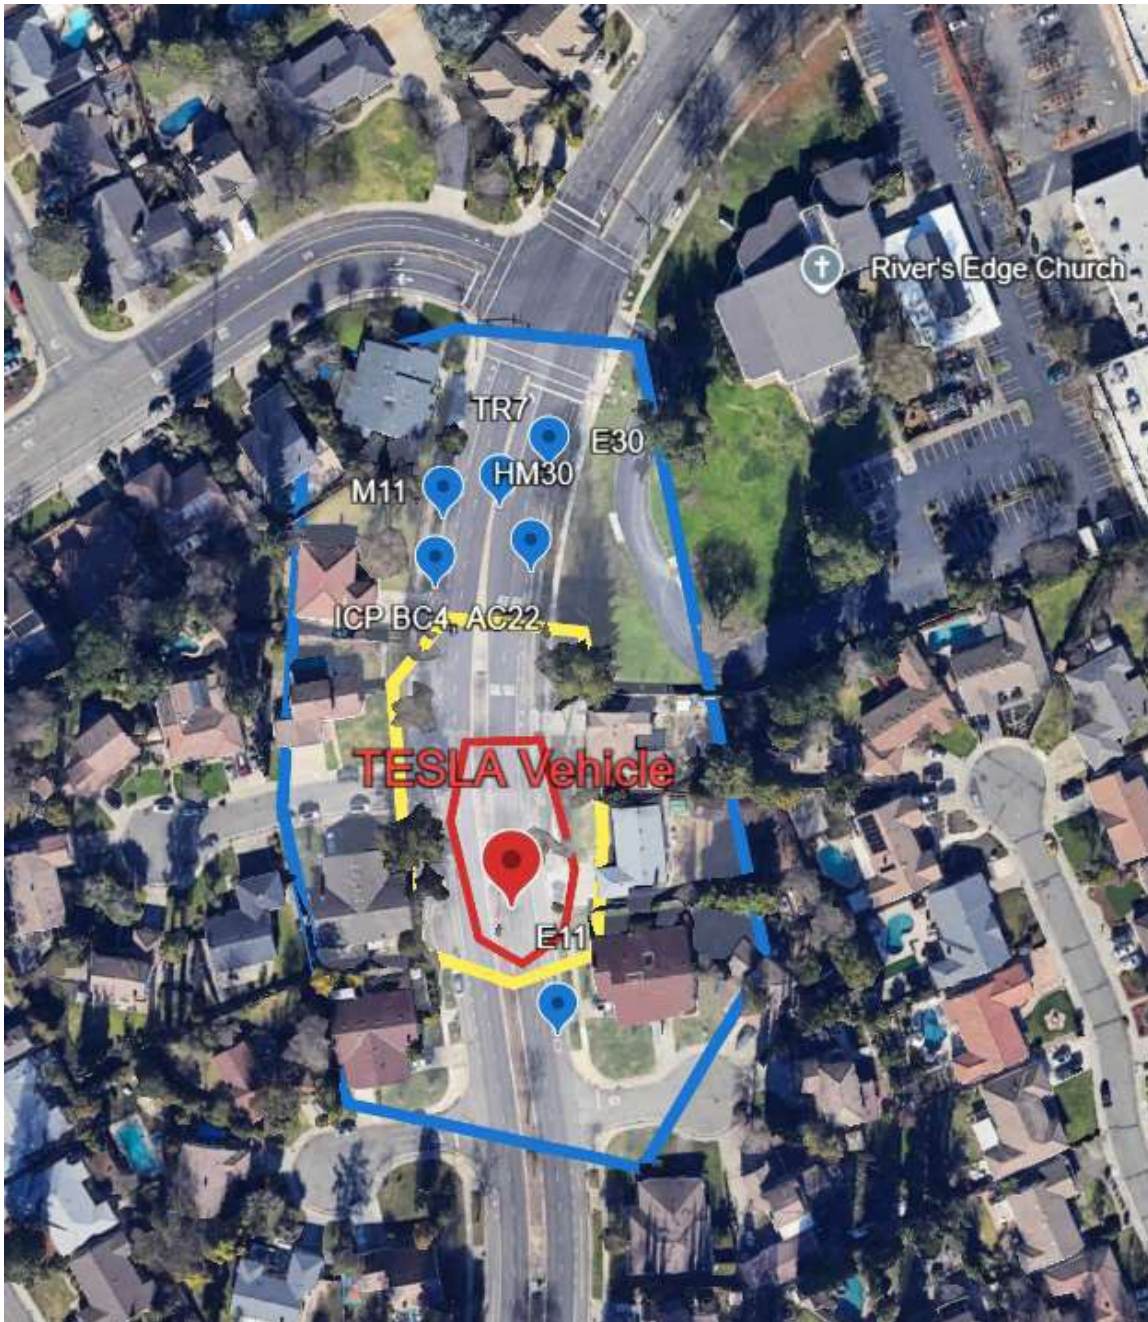
- Hazmat crews arrived later and positioned at the previously established command post location.
- Lacking noticeable winds and unaware of wind direction, command and hazmat units positioned themselves approximately 200' to the north of the incident.
- Technical Reference position was established to look up best practices for the hazards presented by EV LIB.
- Hazmat Group Supervisor, Hazmat Assistant Safety Officer (ASO), Entry Team, and Back-Up Team were established.
