NO.: 24-129  
DATE: August 15, 2024  
TO: All Personnel  
FROM: Robert Logan, Deputy Fire Chief, Employee Services  
SUBJECT: Green Sheet – LAFD Truck/RV Fire – Firefighter LODD

# GREEN SHEET

### Firefighter Line of Duty Death

Incident Number LAC 24-203895

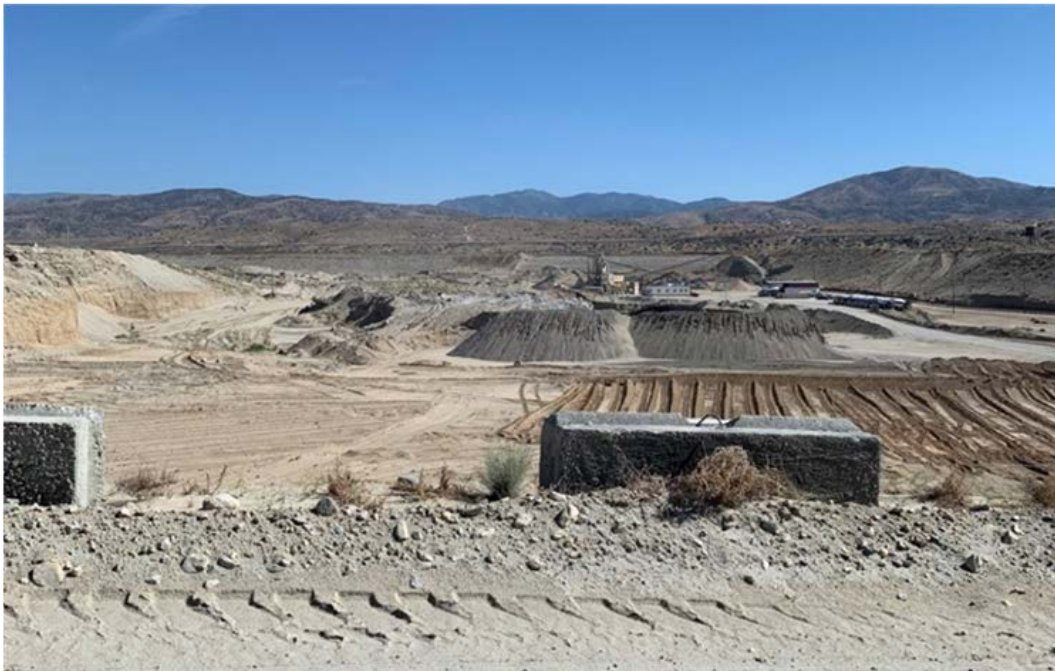
The incident occurred within a sand and gravel quarry in the City of Palmdale, California.

*Looking south at the quarry from the access road.*

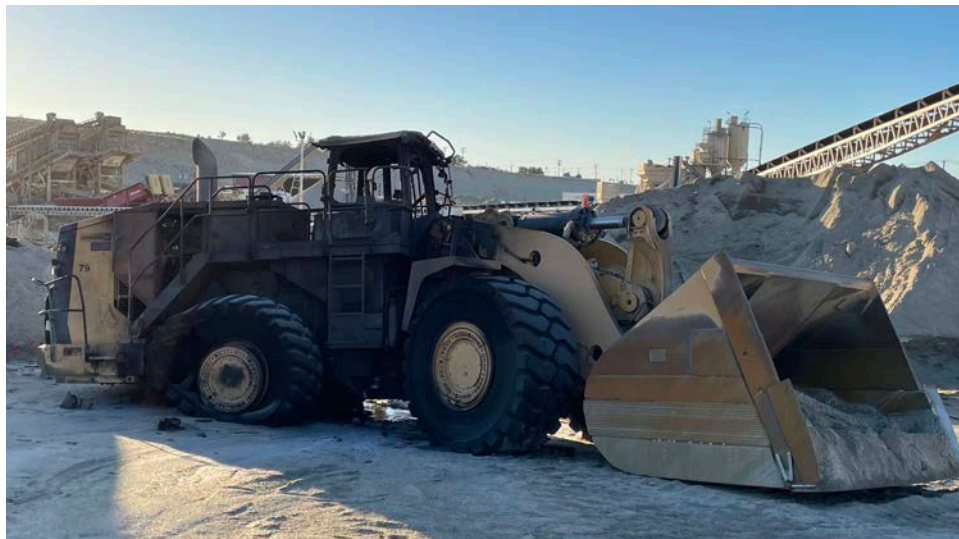
- The vehicle involved was a diesel-powered 2015 Caterpillar 988K Wheel Loader.
  - Engine: 541 hp, 18 L, CAT C18 ACERT™
  - Dimensions: 40 feet long, 13.7 feet high, and 12.7 feet wide
  - Operating weight: 112,574 lbs.
  - Rated payload: 16 tons for loose material

*Right side of wheel loader*

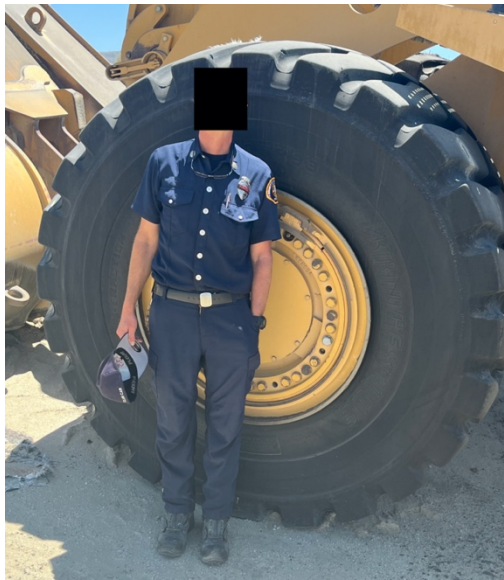
- The wheel loader tires were Bridgestone V-Steel N-Traction (VSNT) 35/65R33 radial tires.
  - The front tires were inflated with compressed ambient air to 100 psi.
  - The rear tires were inflated with compressed ambient air to 90 psi; no water was added for ballast.
  - The overall tire diameter was 81.7 inches, and the overall tire width was 35.6 inches.

*Left-front tire with 6.1-foot tall firefighter for height comparison.*

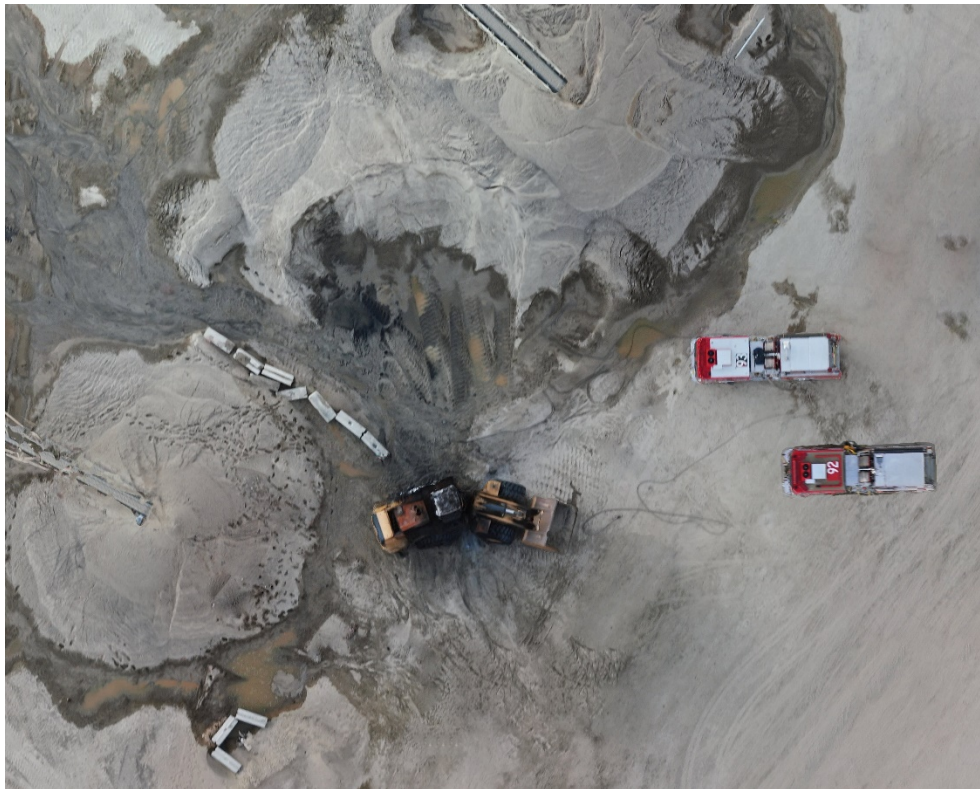
*Overhead view. Some photos have been edited out of respect.*

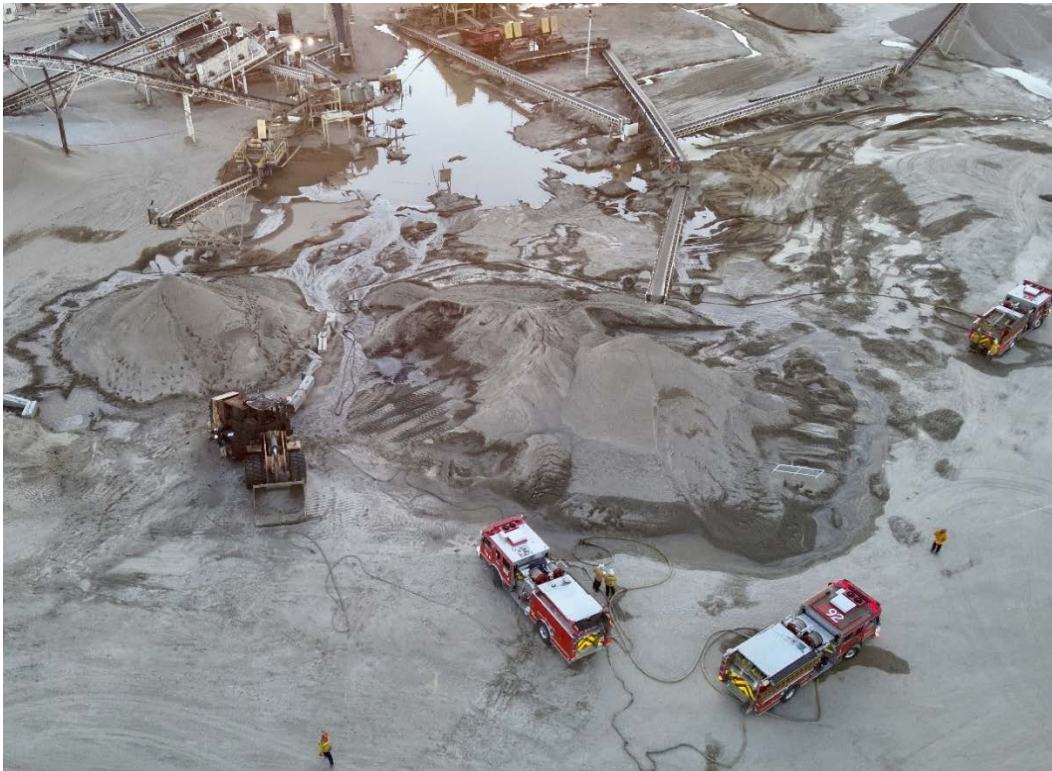
***Looking west (note that E92 moved after the explosion).***

The left-rear tire exploded at 1408 hours. This explosion occurred:
