NO: 25-138  
DATE: August 6, 2025  
TO: All Personnel  
FROM: Daniel Eddy, Assistant Fire Chief, Operations  
SUBJECT: Green Sheet – CalFire Border 79 Incident

# GREEN SHEET

### "Border 79"

December 10, 2024  
Incident Number 24CASDU026957  
Barrett Truck Trail  
Dulzura, California

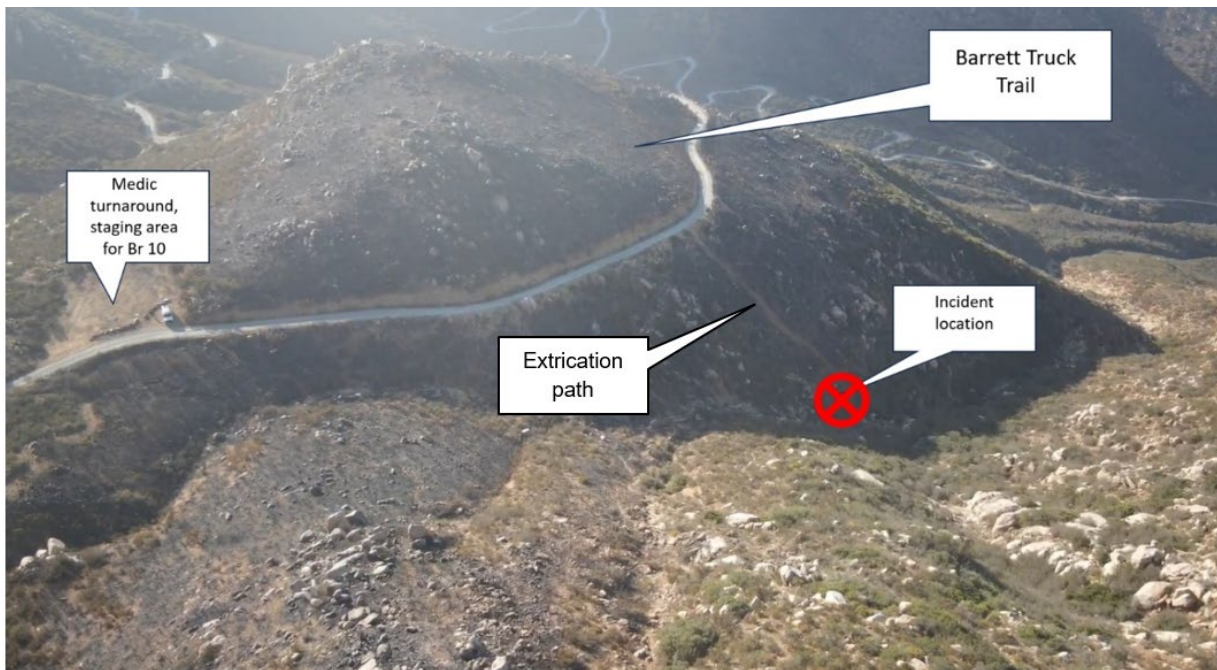
### Border 79 Incident Accident Location

On Tuesday, December 10, 2024, at approximately 1651 hours, resources were performing containment operations on the Border 79 incident, a vegetation fire near the Barrett Truck Trail in the community of Dulzura, CA, in the unincorporated area of San Diego County, California. While engaged in suppression activities, two large boulders rolled down the hill towards a hand crew, striking the sawyer and puller, who sustained moderate to severe injuries.
