BULLETIN

NO: 26-017
DATE: February 11, 2026
TO: All Personnel
FROM: Daniel Eddy, Assistant Fire Chief, Operations
SUBJECT: Green Sheet – SDFD's South Mission Beach Jetty Incident

GREEN SHEET

"South Mission Beach Jetty Incident"

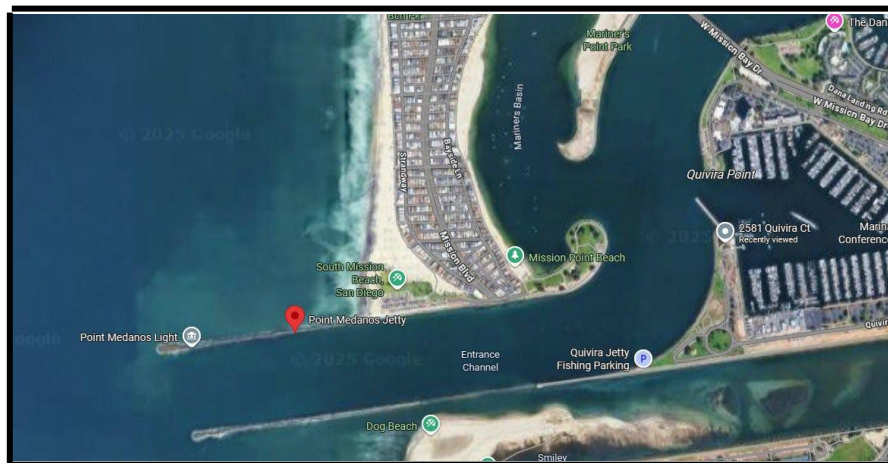
**South
Beach
Jetty
Location**

- The incident occurred along the north side of the Mission Bay channel jetty at South Mission Beach in the Mission Beach community of San Diego, California. The victims were located near the tip of the roughly 2,180-foot-long jetty, beyond the Point Medanos Light. The jetty is constructed with riprap made of very large rocks with large void spaces between them, creating very rugged, jagged, and hazardous terrain that is difficult to cross on foot.
